**MARYLAND HISTORICAL TRUST
DETERMINATION OF ELIGIBILITY FORM**

Property Name: Landsdale (Lansdale) Farm Inventory Number: F-7-77
Address: 4504 Ed McClain Road City: Monrovia Zip Code: 21770
County: Frederick USGS Topographic Map: Urbana
Owner: Monocacy Investments M.C., L.L.C. Is the property being evaluated a district? ☐ yes
Tax Parcel Number: 44 Tax Map Number: 88 Tax Account ID Number: 246339
Project: Green Valley Active Adult Community Agency: Maryland Department of the Environment
Site visit by MHT Staff: ☒ no ☐ yes Name: _____ Date: _____
Is the property located within a historic district? ☐ yes ☒ no

MARYLAND HISTORICAL TRUST
NR-ELIBILITY REVIEW FORM

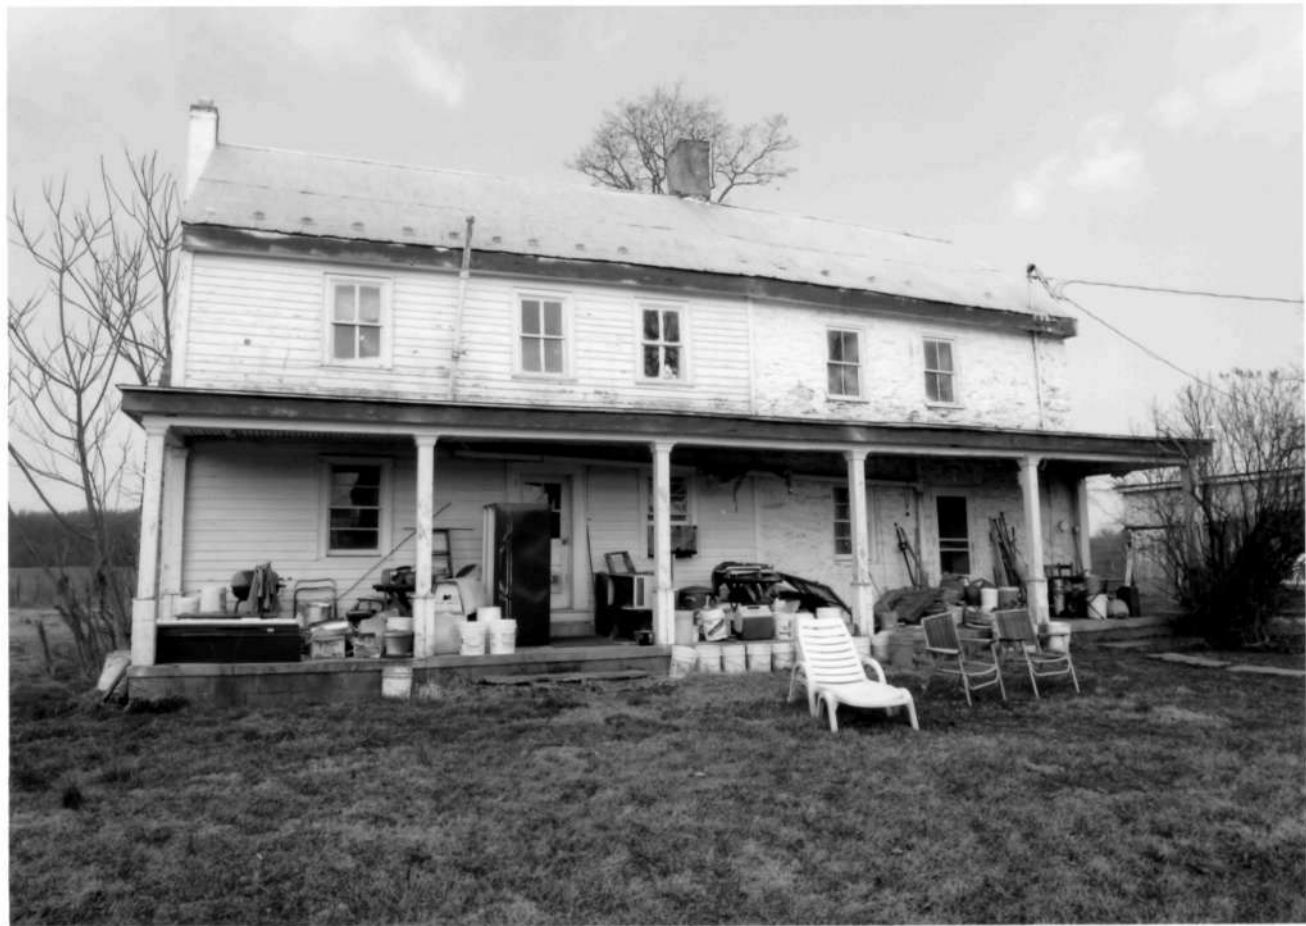
2 OF 20

DWELLING, E ELEVATION, LOOKING WEST

The existing five-bay building occupies an L-shaped footprint comprising of a central block and ell, which are supported by a random rubble foundation. The two-story, stone and wood-frame building faces east and terminates in a gable roof sheathed in corrugated metal panels. Three chimneys pierce the roof. One chimney is off-center in the central block; one chimney is located on the south elevation; and one chimney is located in the ell's west elevation. The building is sheathed in a combination of German lap siding, bevel siding, cinderblock, and asbestos shingles. Windows reflect a variety of periods and include horizontal, two-over-two light, double-hung, wood-sash; six-over-six light, double-hung, wood-sash; four-light, fixed, wood-sash; and one-over-one light, double-hung, wood-sash units. All windows in the masonry sections are supported by wood lintels and enframed by simple board surrounds. An open five-bay porch spans the east elevation. Simple square piers, with modest capitals and square bases, rise to a flat roof. The porch is supported by a poured concrete foundation. Surviving additions extend from the south and west of the original stone block. Ornamentation is limited to the box cornice and the porch columns. Bulkhead doors on the porch provide access to the basement, which extends under the early stone house.

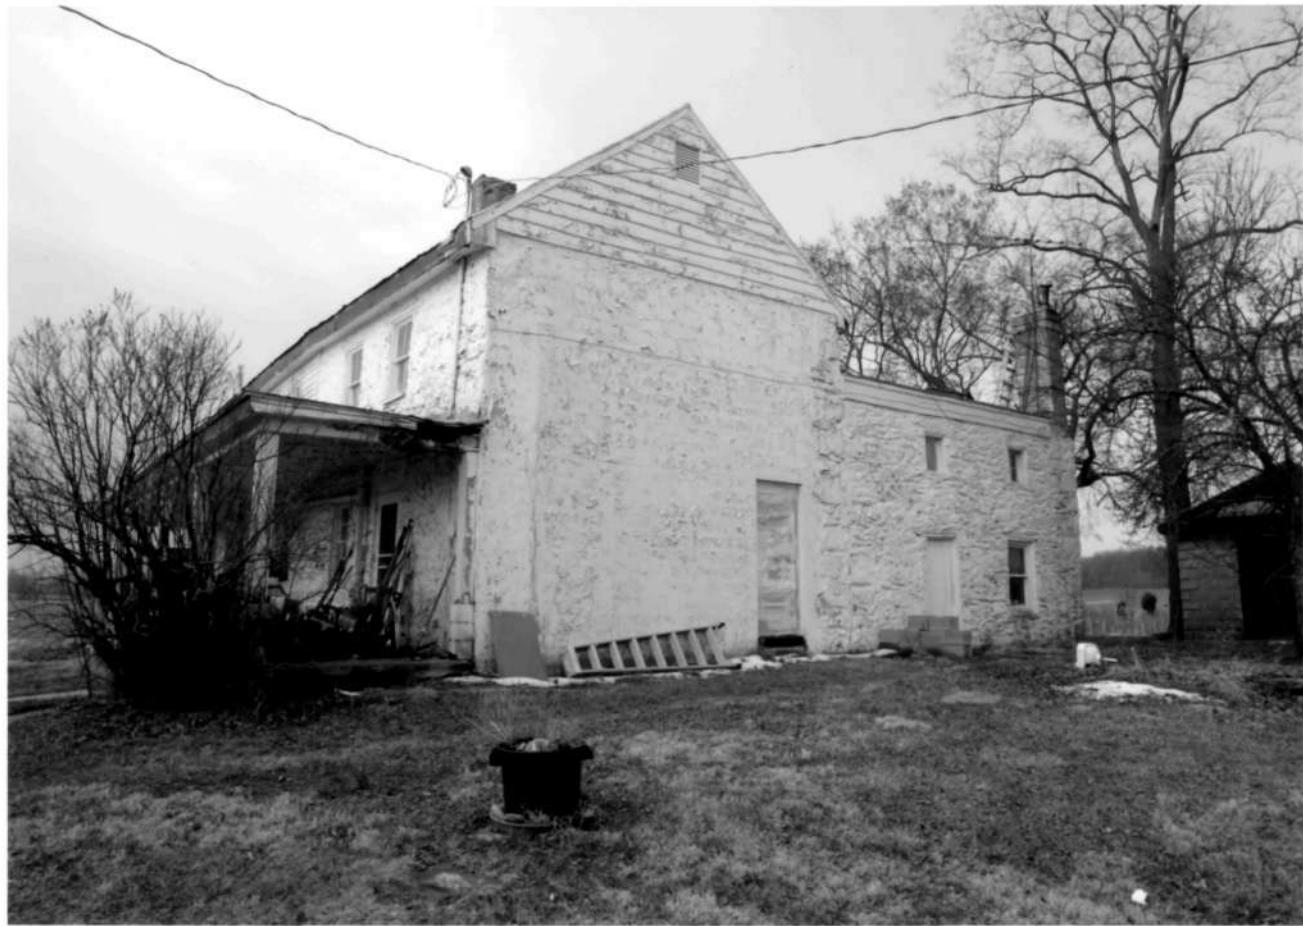
S of 20

DWELLING, H 224. Looking S

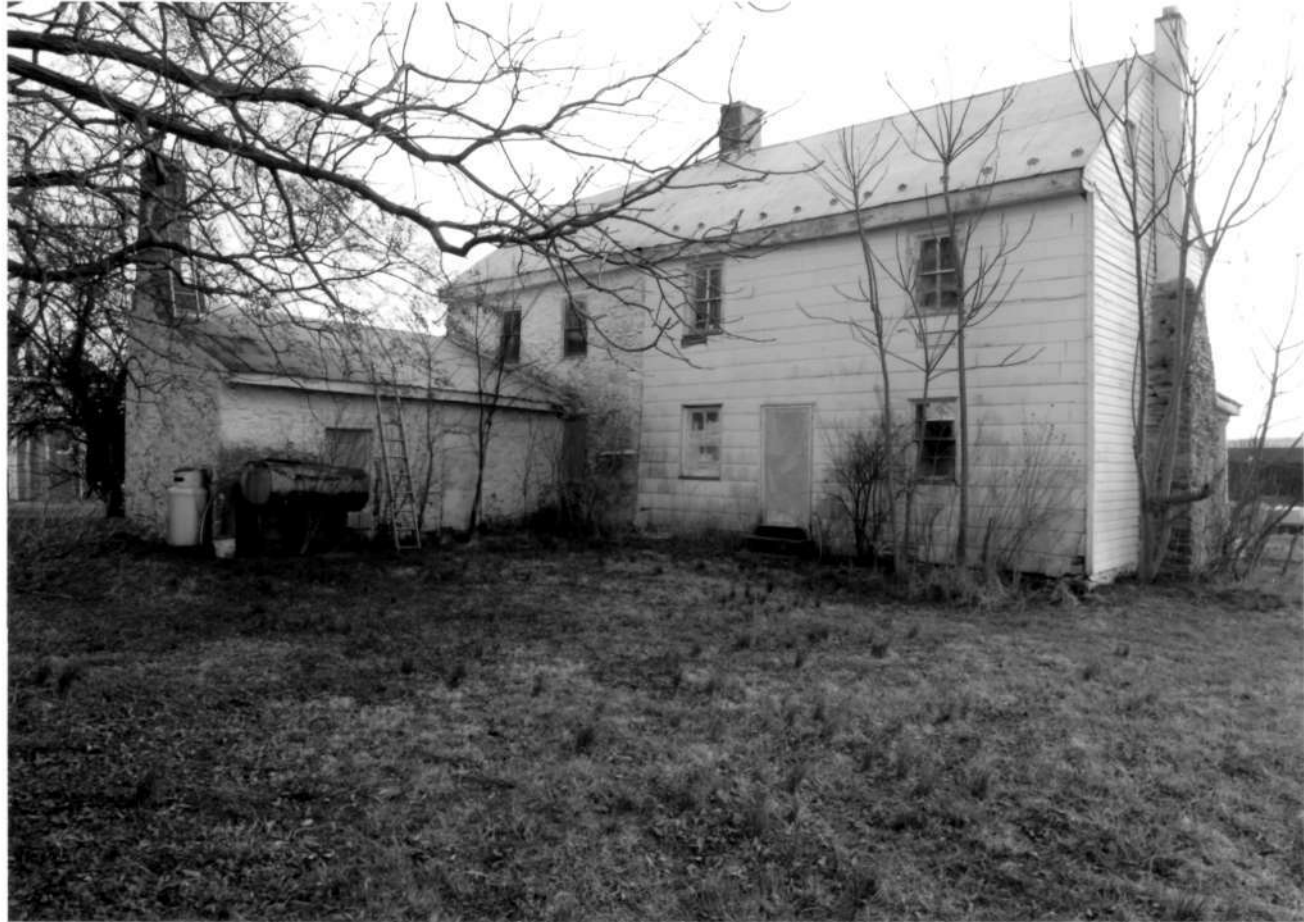
5 OF 20

DWELLING, W 26N LOOKING NE

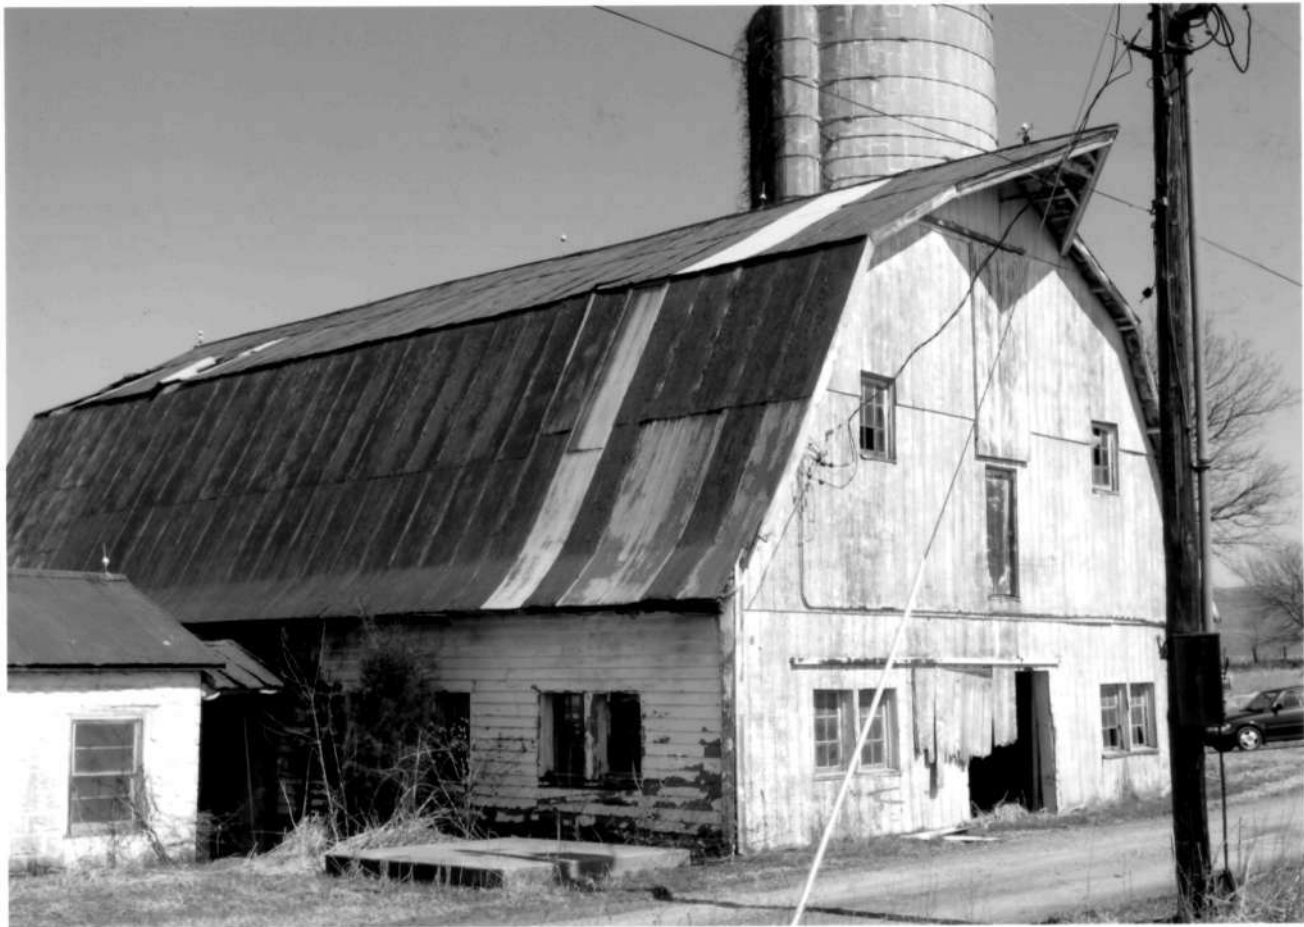
7 OF 20

DAIRY BARN, WELLY WORKING 112

The single-story plus loft ca. 1950 dairy barn occupies a rectangular footprint. The building terminates in a gambrel roof sheathed in corrugated-metal panels. Lighting rods and vents characterize the roof. The building rests on a poured-concrete foundation. Cladding materials include vertical wood plank siding on the north elevation, beaded-board siding on the south elevation, and wood clapboard siding on the east and west elevations. Openings consist of beaded-board sliding track doors and nine-light, wood windows. A beaded-board sliding track door is centered on the lower level of the south elevation. Paired nine-light, fixed-sash windows flank the door. Two nine-light, fixed-sash wood windows and one beaded-board wood door are located in the loft level. The fenestration on the north elevation is similar to that on the south elevation. However, the sash is no longer extant in the easternmost window and the sash are no longer extant in the two windows located in the loft level. A sliding track door is located on the first floor; no door is present in the loft level.

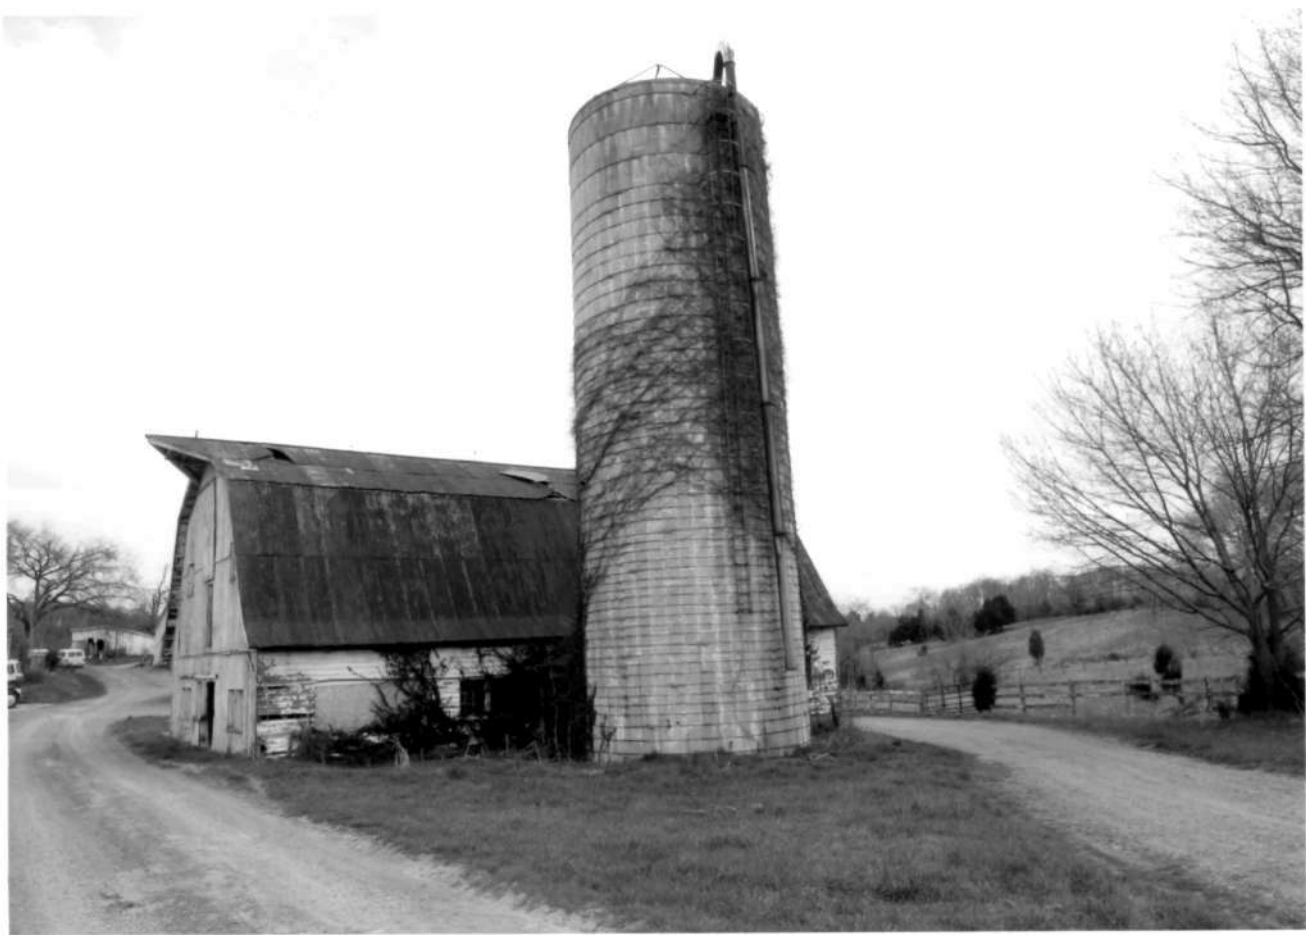
8 OF 20

DAIRY BARN & SILO, E END WORKING WEST

A ca. 1930 poured-concrete silo with metal rings is located east of the barn. The silo's roof is no longer extant. A single-story concrete-block hyphen connects the silo to the barn. The hyphen terminates in a side-gable roof sheathed in corrugated metal panels. Plywood covers a door opening on the south elevation.

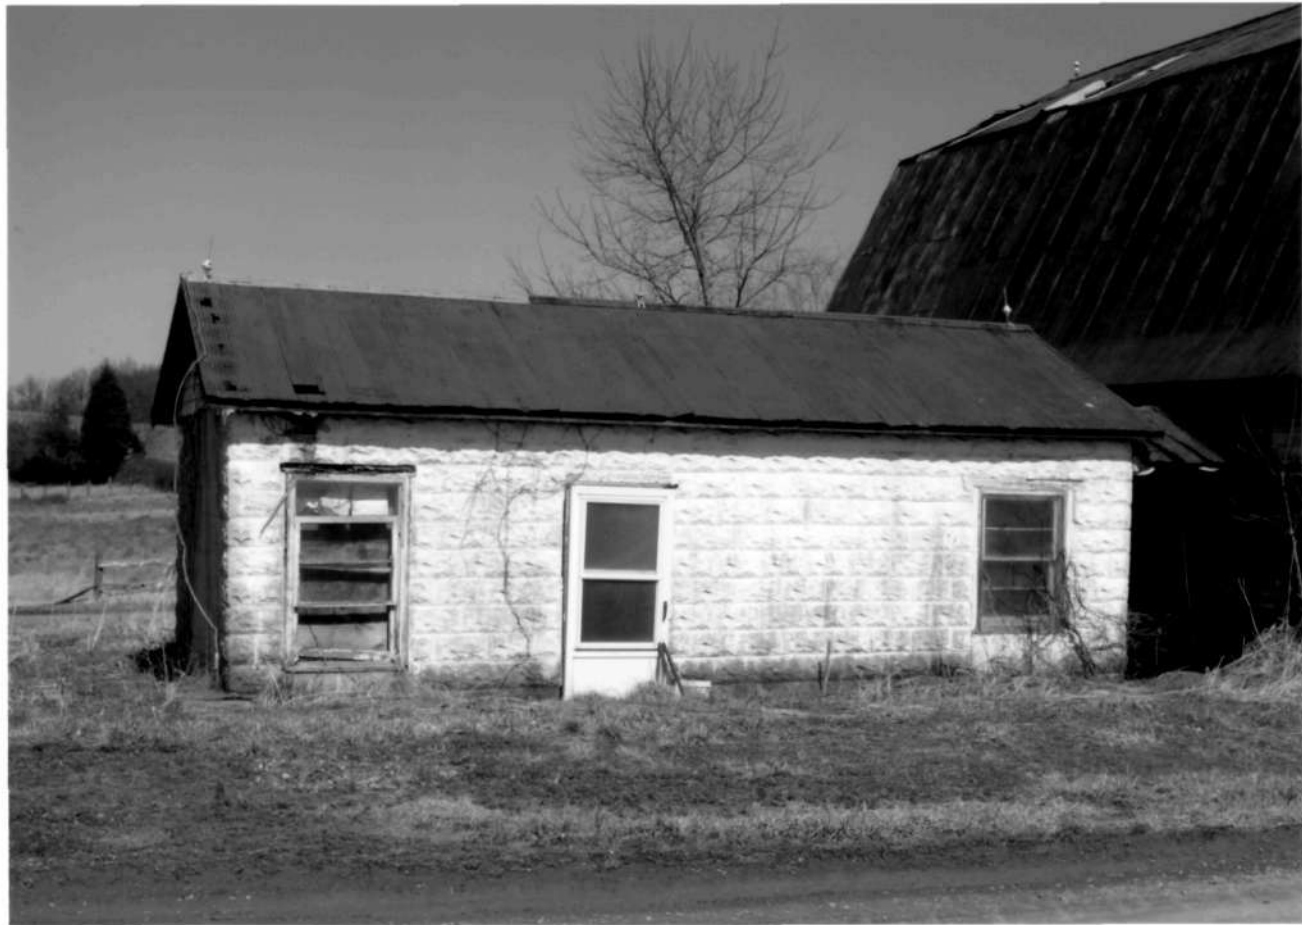
9 OF 20

DAIRY, S ELY WORKING M

A ca. 1930 concrete-block dairy is located west of the dairy barn. The building faces south and occupies a rectangular footprint. The single-story building terminates in a side-gable roof sheathed in corrugated metal. Three lightning rods characterize the roof. Rock-face concrete block clads the building. The three-bay building has an asymmetrical façade. Openings are located on each elevation. Two two-over-two light, double-hung, wood-sash windows with horizontal muntins flank a two-light, single-panel vinyl storm door on the building's south elevation. A window opening is located on the west elevation; the sash is no longer extant and the opening is infilled with concrete block. Two one-over-one light double-hung, vinyl-sash windows characterize the north elevation. A wood door is located on the barn's east elevation. A concrete-block wall on the east elevation connects the dairy to the dairy barn. The dairy's roof extends over the wall, creating a partially enclosed bay.

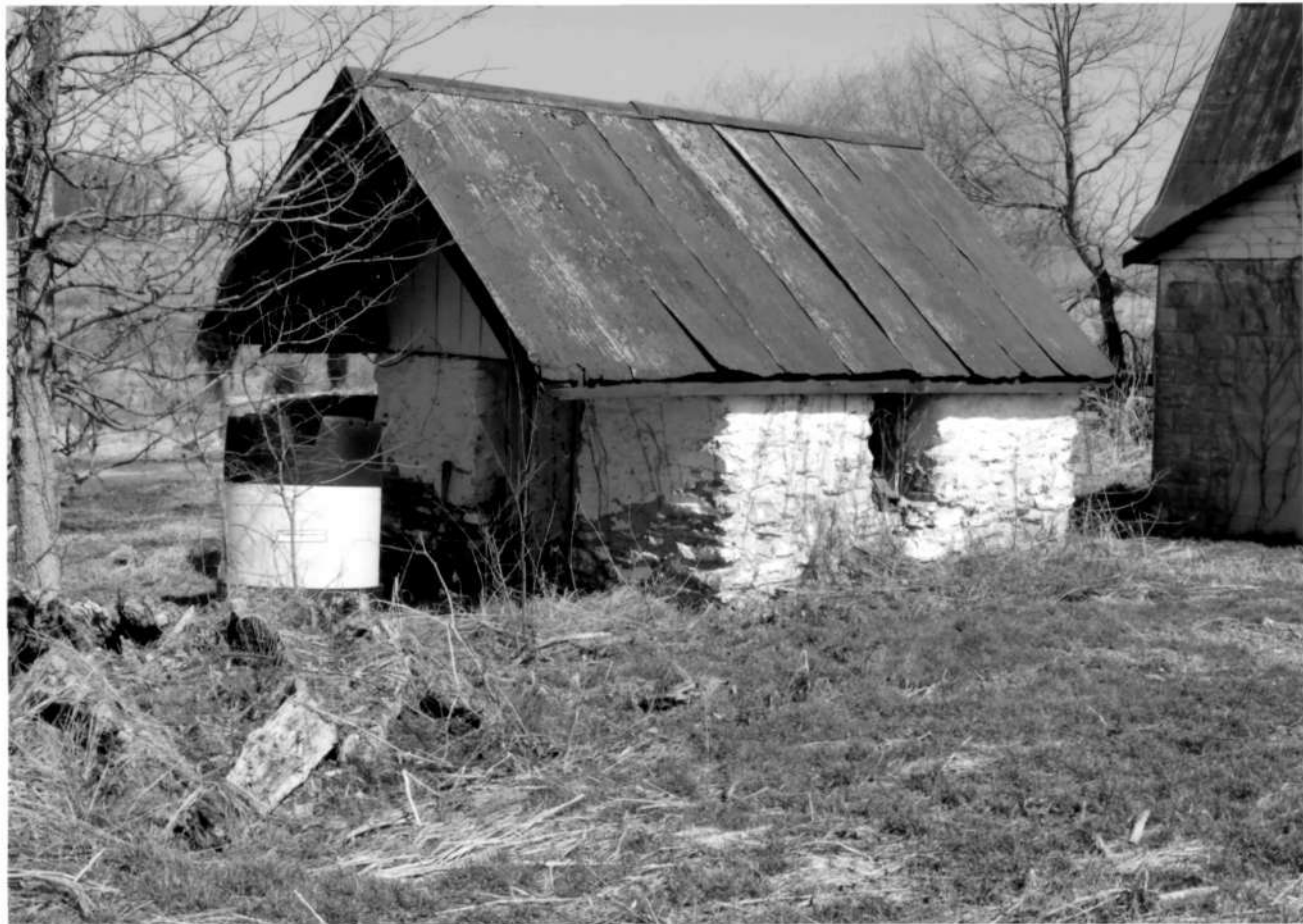
20 MARCH 2007
SPRING HOUSE, WELCH WORKING ME
10 OF 20

The early eighteenth-century rubble stone springhouse is located west of the dairy. The building occupies a rectangular footprint and faces west. The foundation was not visible. The front-gable roof is sheathed in corrugated metal. The roof overhangs the building on the west elevation. Vertical wood plank siding is located in the gable ends. Openings are centered on each elevation. A vertical wood plank door is located on the west elevation. One window is found in each of the north, east, and south elevations. A four-light, wood-sash casement window characterizes the north elevation. The sash were no longer extant on the south and east elevations.

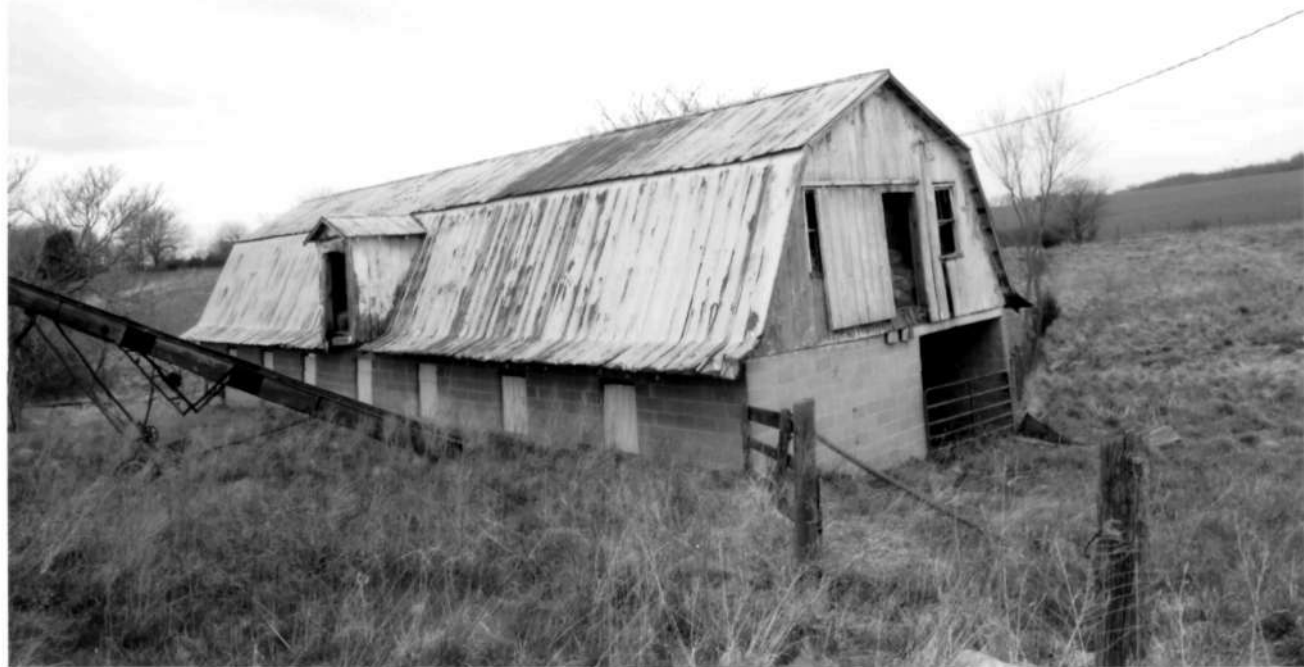
2nd DAIRY BARN, W ELEV LOOKING NE
11 OF 20

A ca. 1970, one-story plus loft, dairy barn is located northeast of the dwelling. The concrete-block and wood-frame building occupies a rectangular footprint. The building faces south and terminates in a gambrel roof sheathed in crimped, standing-seam metal. A gable dormer is located on the west elevation. The lower level is constructed of concrete-block and the loft

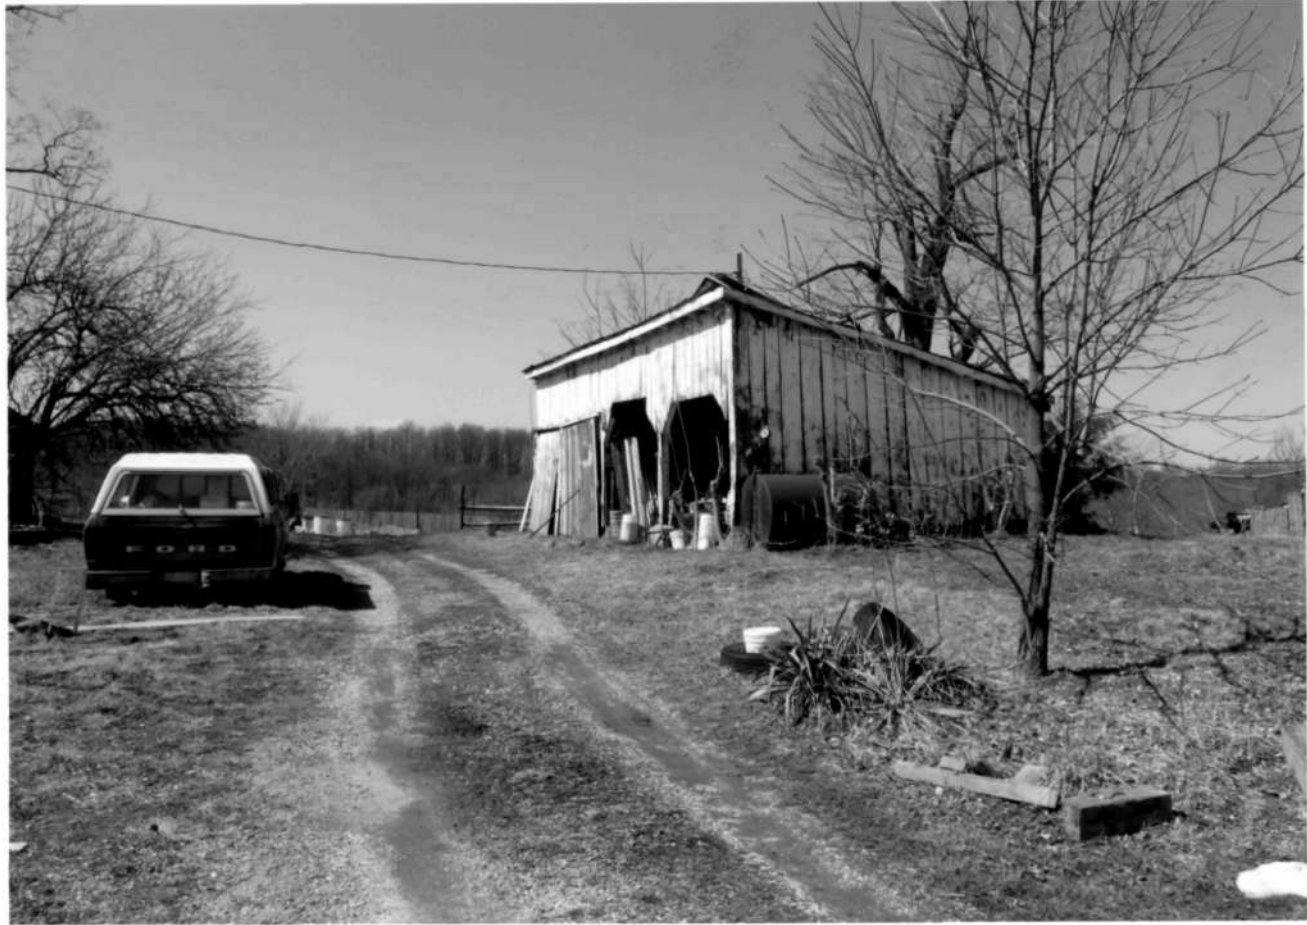
12 OF 20

WOOD EQUIPMENT SHED, SEEN LOOKING N

The mid-twentieth-century equipment shed occupies a rectangular footprint and faces south. The one-story wood-frame building terminates in a shed roof sheathed in corrugated metal. The three-bay building is clad in vertical wood plank siding. The wood posts dividing the bays rest in poured-concrete piers. One, vertical wood plank, sliding-track door is located in the west bay. One multi-light, fixed-sash wood window and one opening with the sash missing are located on the west and north elevations.

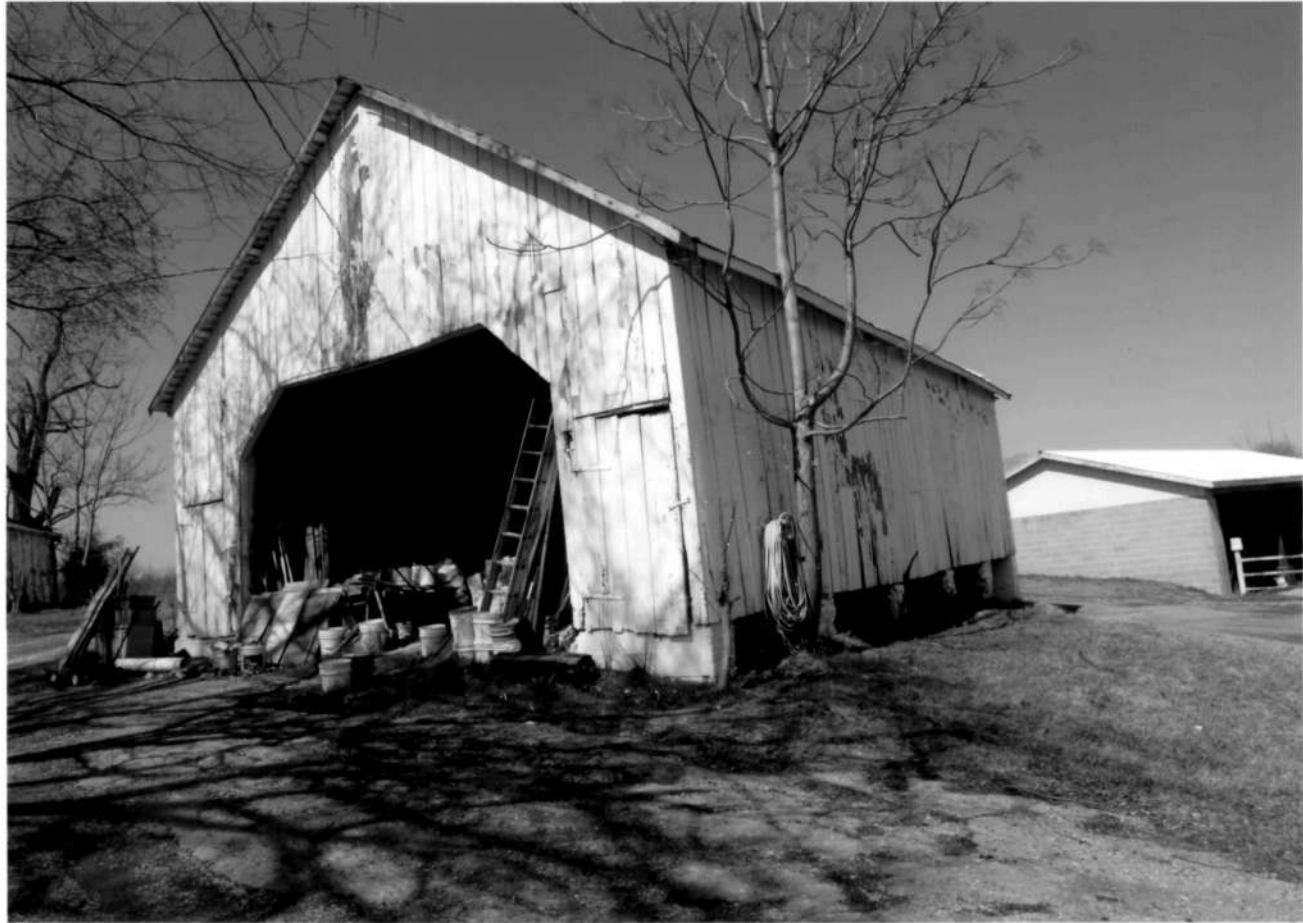
13 of 20

CORN CRIB, SEEN. LOOKING N

A single-story, wood-frame, two-bent, three-bay corncrib/wagon shed is located northeast of the dwelling. The ca. 1930 building faces south and occupies a rectangular footprint. The building rests on concrete-block and rubble-stone piers and terminates in a front gable roof sheathed in corrugated metal. Vertical wood plank siding clads the building. The central passage located on the south elevation does not continue through to the north elevation. Two vertical wood-plank passage doors are located in the north and south elevations of each corncrib. There is visual evidence that a fire occurred in the corncrib, burning the corn crib's east wall.

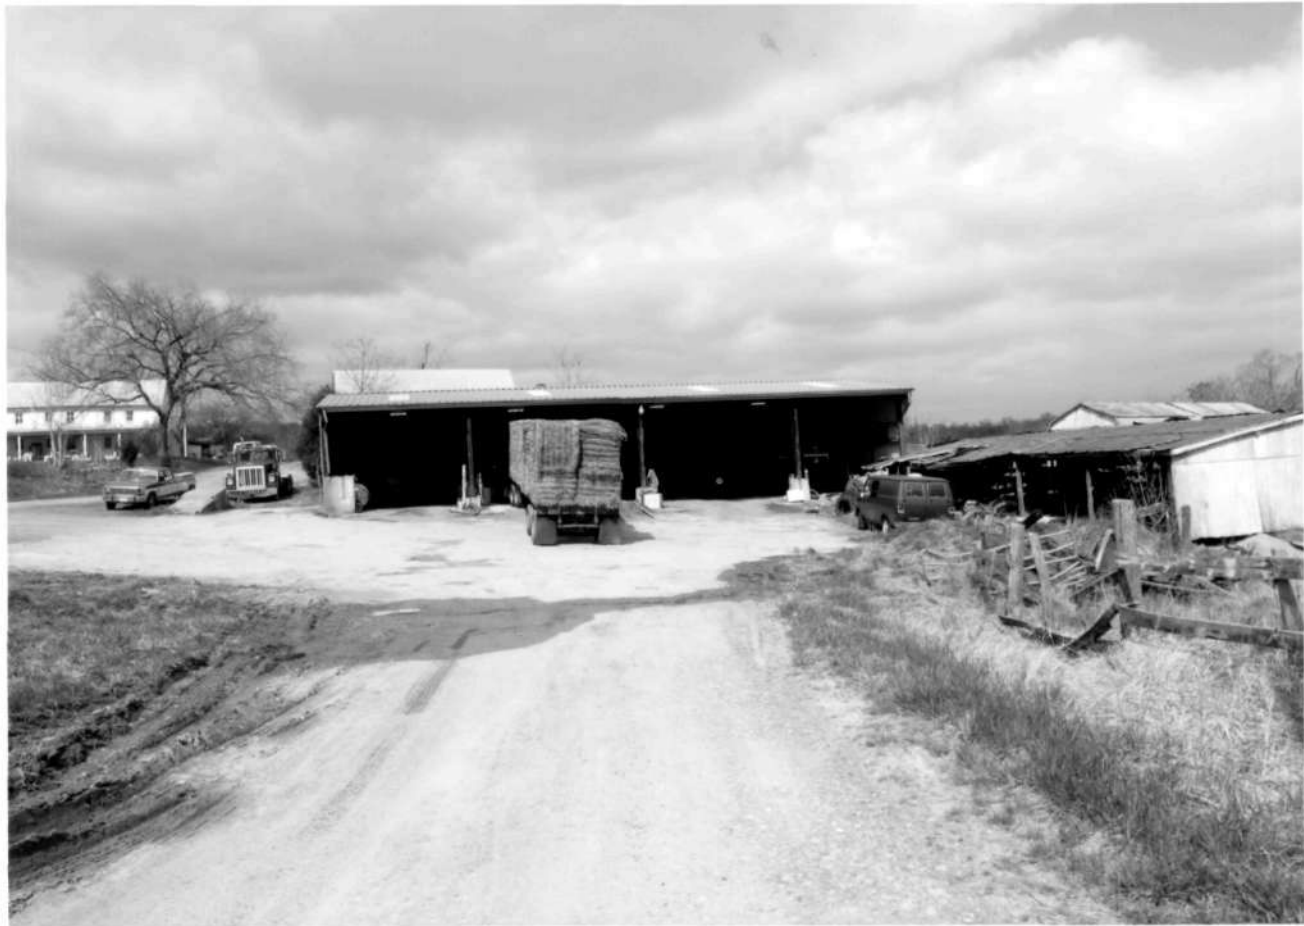
14 OF 20

METAL EQUIPMENT SAID, 2 264 WORKING WEST

A late twentieth-century, metal-frame equipment shed occupies the footprint of a former bank barn. The building faces east. The one-story building occupies a rectangular footprint and terminates in a side-gable roof sheathed in a crimped, standing-seam metal roof. Eight plexiglass panels, centered over each bay, were inserted in the roof to provide light into the building's interior. The prefabricated building has four bays; the metal posts dividing the bays rest in concrete piers clad in metal. Window openings on the west and north elevations and a door opening on the south elevation were infilled with metal panels. The ramp for the former bank barn abuts the west elevation of the shed. Poured-concrete walls support the earthen ramp.

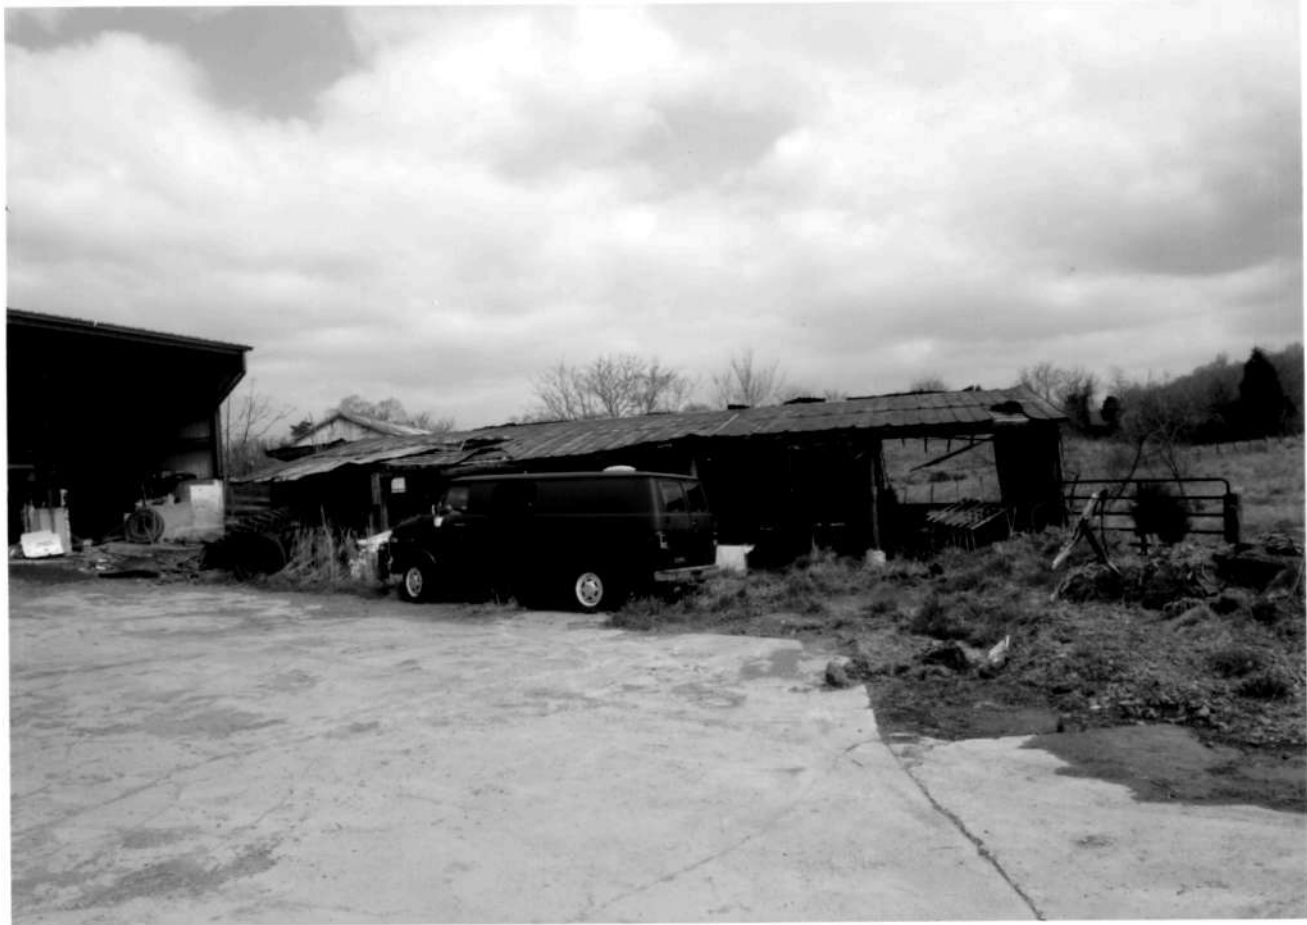
K. KURANDA
20 MARCH UNIT
ANIMAL SHELTER, S 264 100000 10000
15 OF 20

A mid-twentieth-century wood-frame, single-story animal shelter is located north of the metal equipment shed. The south-facing building rests on a poured-concrete and dirt floor. The building has five bays; rough-hewn poles support the side-gable roof on the south elevation. The south slope of the roof is sheathed in standing-seam metal while the north slope is sheathed in corrugated metal panels. The poles rest in poured-concrete piers set in plastic buckets. Piers also support the building on the east and west elevations; some of the piers are constructed of concrete block. A poured-concrete retaining wall supports the building on the north and east elevations, suggesting that the building occupies the footprint of an earlier building. The building is clad in vertical wood planks of various widths.

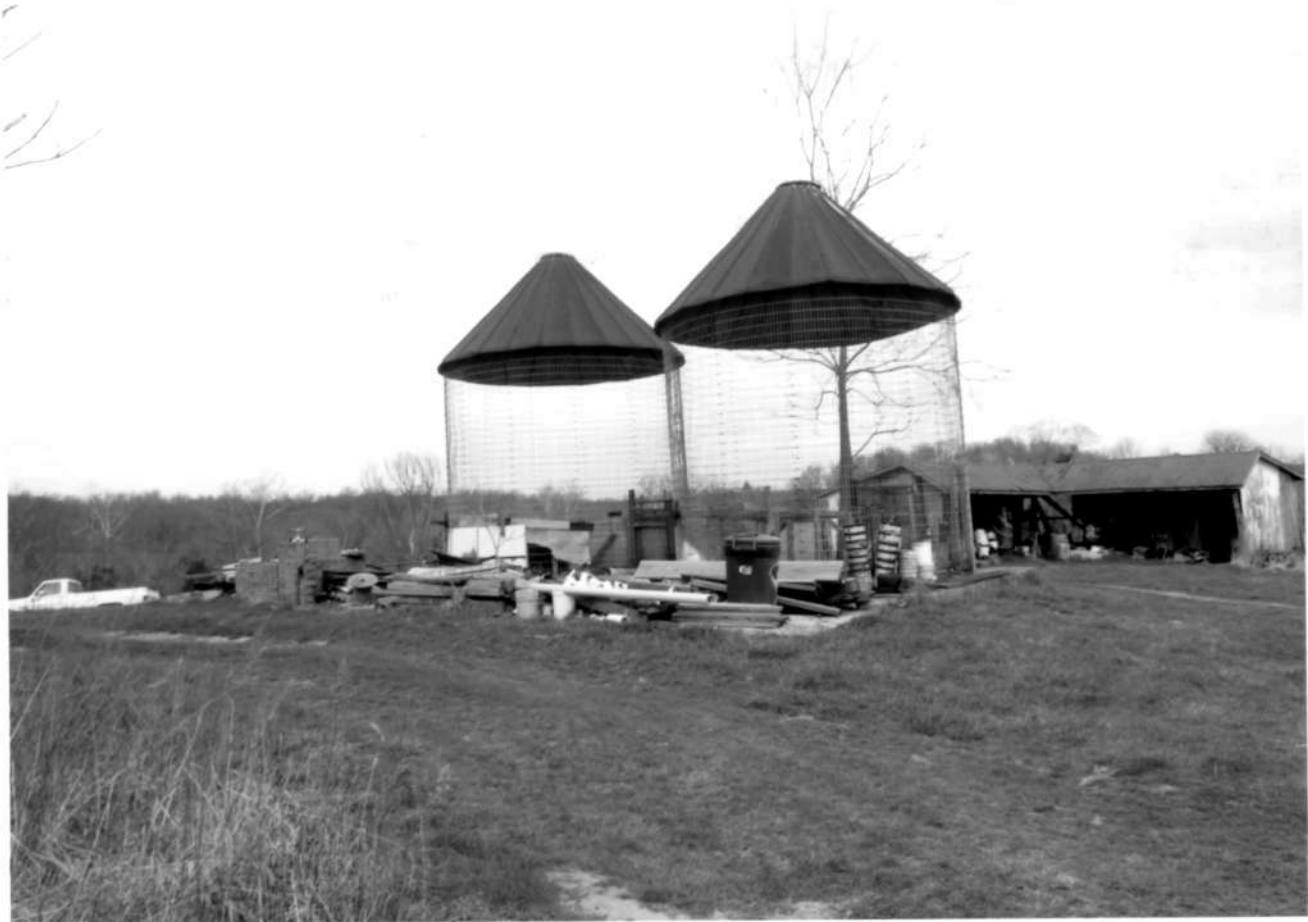
16 OF 20

HEAL CORN CEIBS, LOOKING NW

Two metal wire corncribs are located north of the dwelling. The ca. 1940 corncribs rest on a poured-concrete slab on top of concrete-block. A conical standing-seam metal roof caps each corncrib.

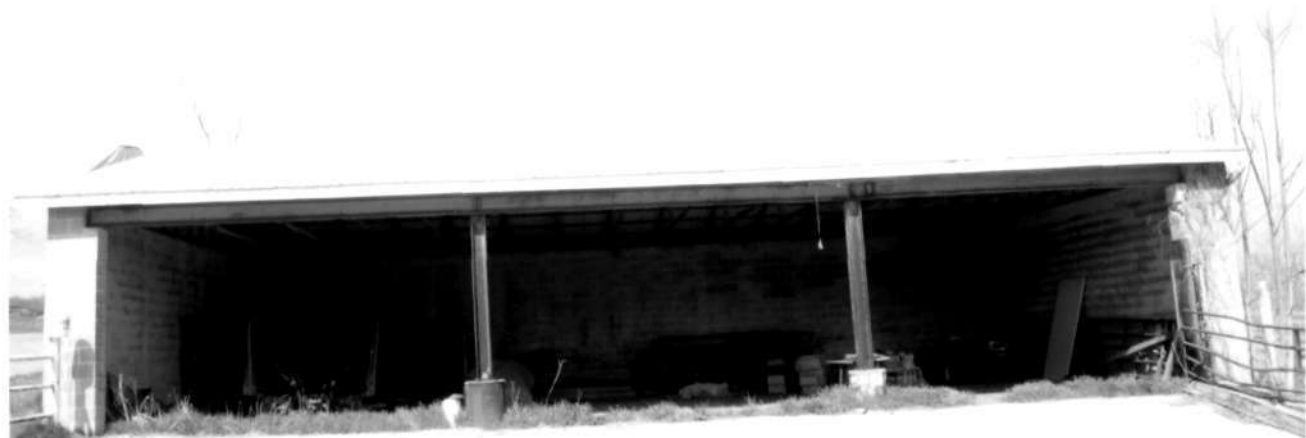
17 06 20

CONCRETE - block EQUIPMENT SHED, SEVEN WORKING MACH

A late twentieth-century, single-story, three-bay equipment shed is located north of the corn crib. The building, which faces east, occupies a rectangular footprint and rests on a poured-concrete slab. The building terminates in a side-gable roof sheathed in corrugated-metal panels. Prefabricated metal panels are located in each gable end. Three metal I-beams resting on poured-concrete piers encased in metal define the east elevation. The north, west, and south elevations are blind. A poured-concrete pad extends from the east (front) of the building to the adjacent metal equipment shed and the animal shelter.

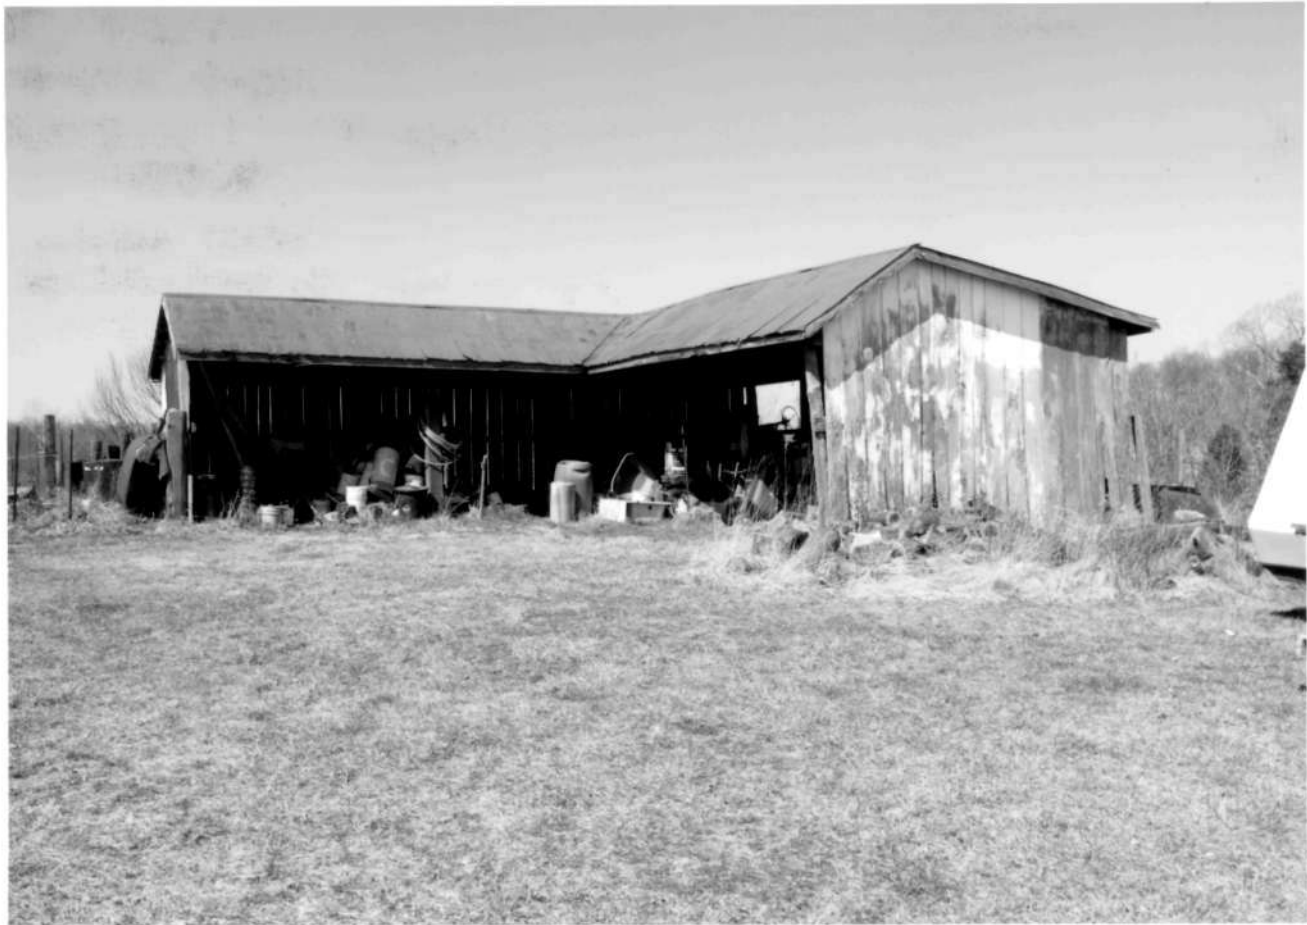
20 MARCH 1977
EQUIPMENT SITED. S ELEV LOOKING NORTH
11 OF 21

A mid-twentieth-century wood-frame equipment shed rests on a dirt floor and faces south. The building occupies an L-shaped footprint and terminates in a side-gable roof sheathed in corrugated metal. Round wood posts support the roof on the south (front) elevation; the posts rest on concrete-block piers. Cladding material is vertical wood plank siding. The south elevation is open; no doors or windows are present on the elevation. The remaining elevations are blind.

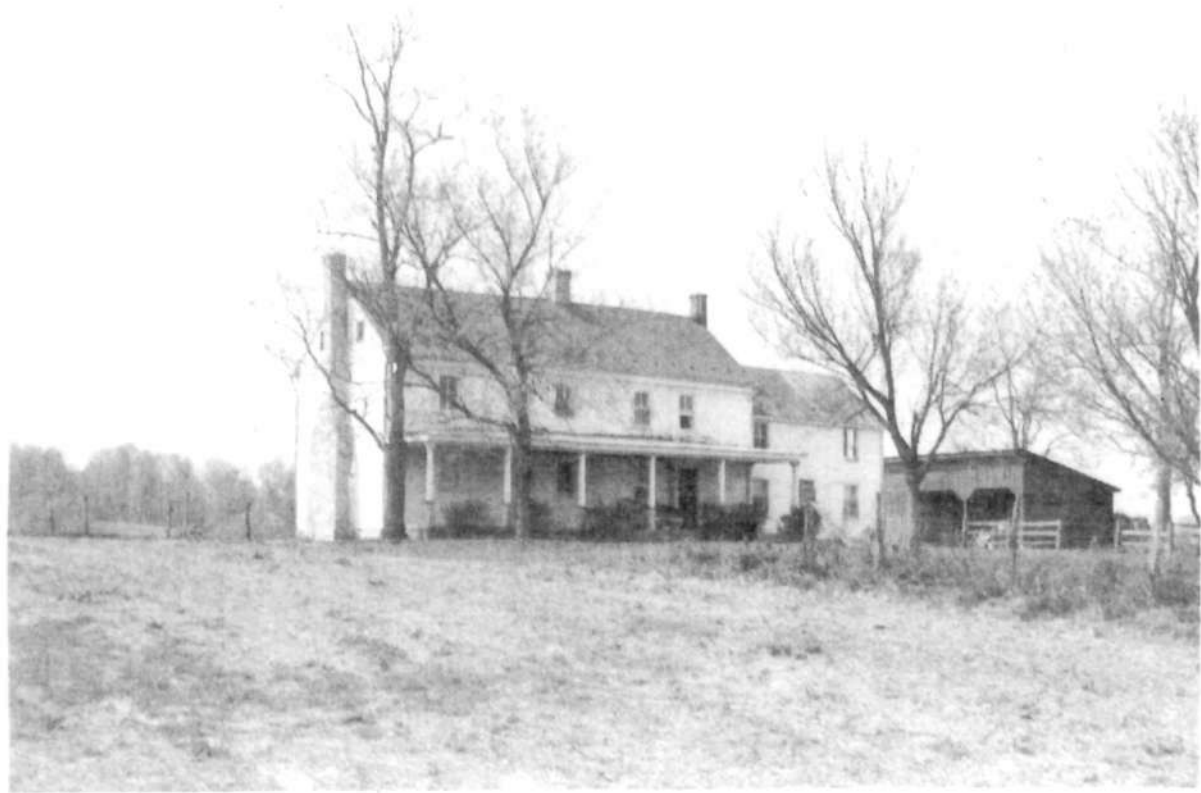
19 OF 20

CA. 1950 VIEW of DWELLING

The ca. 1950 photograph suggests that earlier windows have been replaced by two-light-over-two-light sash with wide muntins throughout the house by that date. The photograph further documents that the open front porch also was added by that date.

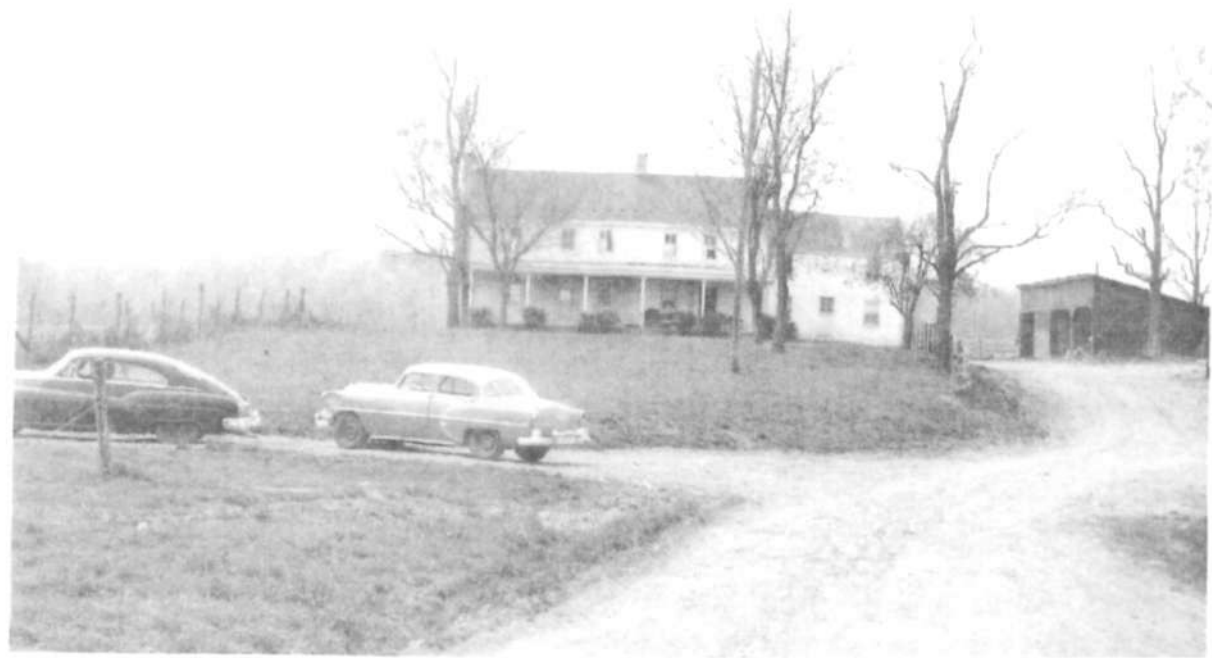
HHH F-7-77
LANDDALE FARM
FREDERICK COUNTY, MD
K. KURANDA
20 MARCH 2007
ca. 1950 view of DULWICH
W OF W

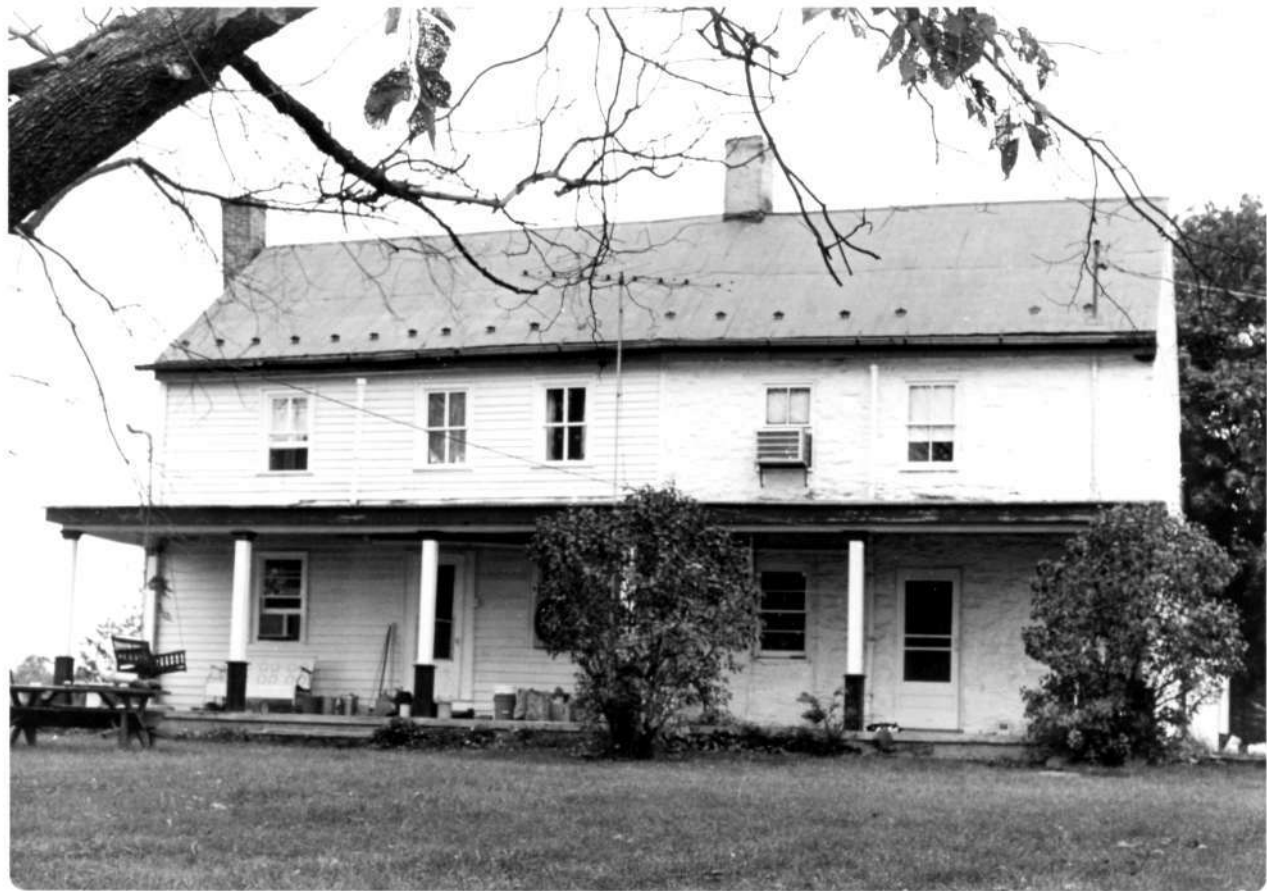
EAST ELEVATION
